# Poročilo o preskusu / Test Report

T211-0469/12

<b>Proizvod / Product</b>	<b>Listov / Pages</b>
Power supply Model: GT-22011-WVVV-X.X Enclosure: TR9KE5000LCP-Y(R)	3
<b>Naročnik / Applicant</b>	<b>Vrsta preskusa / Test procedure</b>
GlobTek, Inc 186 Veterans Dr, Northvale, NJ 07647 / USA	IP40, IP41
<b>Proizvajalec / Manufacturer</b>	<b>Št. Merjencev / No. of Items tested</b>
GlobTek, Inc 186 Veterans Dr, Northvale, NJ 07647 / USA	1
<b>Blagovna znamka / Trade Mark</b>	<b>Mapa predmeta št. / Subject File No.</b>
GlobTek	C20121557
<b>Standardi – predpisi / Standards - regulations</b>	<b>Kraj preskusa / Place of test</b>
IEC 60529:2001	SIQ - Slovenian Institute of Quality and Metrology, Tržaška 2, 1000 Ljubljana, Slovenia
	<b>Opomba / Remark</b>
	/

**Tested product complies with the requirements of stated standards for protection degree IP 40.**

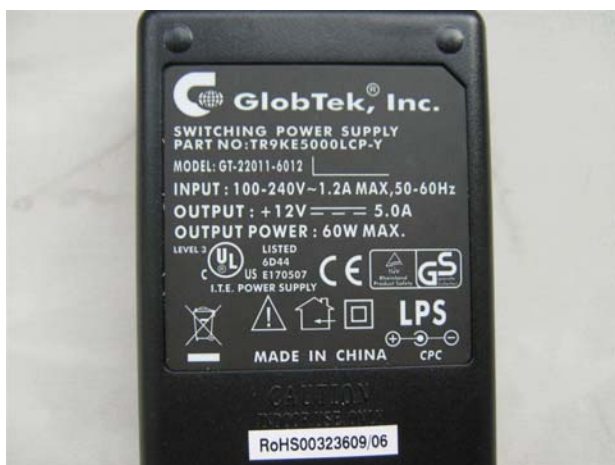
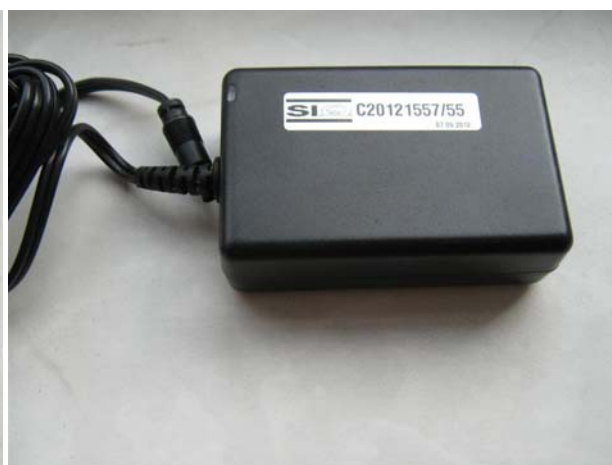
Figure 1

Power supply, model GT-22011-WWVV-X.X, enclosure TR9KE5000LCP-Y(R) was subjected to testing for IP41 degree of protection (Figures 1 and 2).

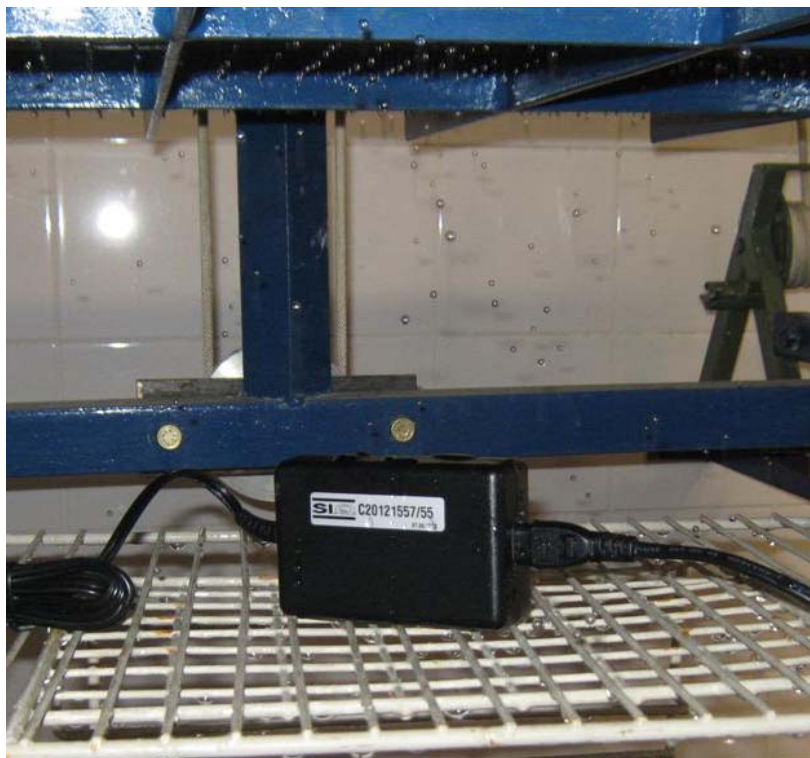
Figure 3: Test position

- Test device, drip box-as specified in standard,
- Water flow rate: 1 mm/min,
- The test sample was placed on the turntable under the drip box in most unfavourable normal position (Figure 3),
- Duration of the exposure: 10 minutes,

**Conclusion:** After the water test there was water on the connector pins.

Immediately following the water test the dielectric strength test with 4000 V a.c. has been conducted between primary and secondary terminals and between primary terminals and enclosure. The voltage was applied and maintained for a period of one minute between the points indicated. The test did NOT pass.

- The rigid test wire was not penetrated into the enclosure
- After the IPX1 test there was water on connector pins.
- After the IPX1 test the dielectric strength test did NOT pass.

**Result:** Following the acceptance conditions, the equipment under test sustained the test conditions for IP40 degree of protection.
