Poročilo o preskusu / Test Report

T211-0476/12

Proizvod / Product Power supply Model: GTGT-81087-WWVV-X.X-W2Z series GT-81041-WWVV-X.X-W2Z series Enclosure: WR9HE1666CCP-F(RVB)	Listov / Pages 4
Naročnik / Applicant GlobTek, Inc 186 Veterans Dr, Northvale, NJ 07647 / USA	Vrsta preskusa / Test procedure IP41
Proizvajalec / Manufacturer GlobTek, Inc 186 Veterans Dr, Northvale, NJ 07647 / USA	Št. Merjencev / No. of Items tested 1
Blagovna znamka / Trade Mark GlobTek	Mapa predmeta št. / Subject File No. C20121557
Standardi – predpisi / Standards - regulations IEC 60529:2001	Kraj preskusa / Place of test SIQ - Slovenian Institute of Quality and Metrology, Tržaška 2, 1000 Ljubljana, Slovenia
	Opomba / Remark /

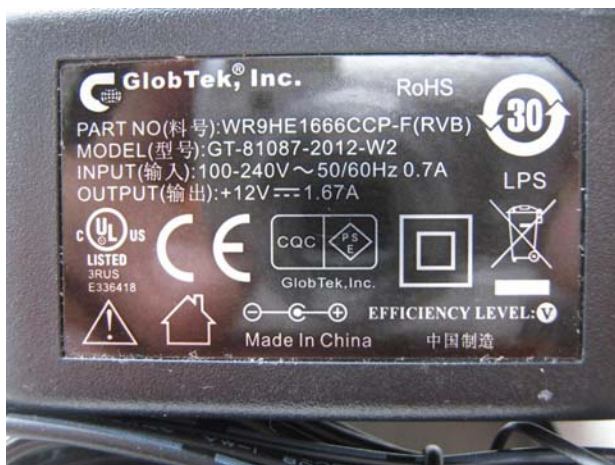
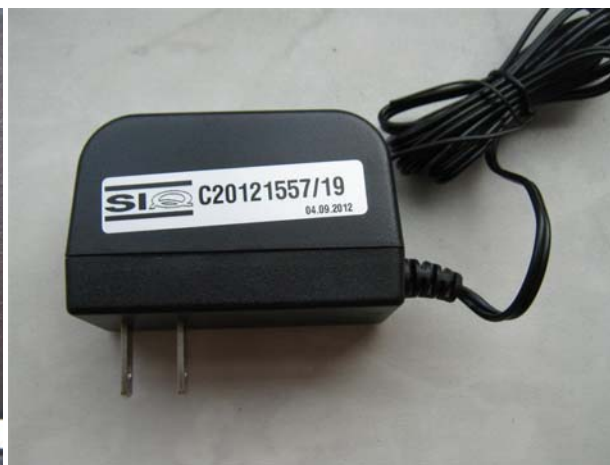
Figure 1

Power supply, model GT-81087-WWVV-X.X-W2Z series and GT-81041-WWVV-X.X-W2Z series, enclosure WR9HE1666CCP-F(RVB) was subjected to testing for IP41 degree of protection (Figures 1 and 2).

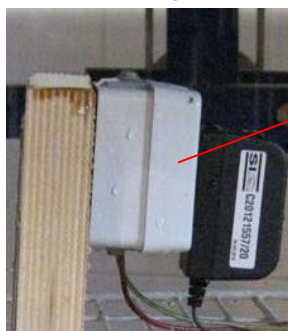
Figure 3: sample unit

During the testing the power supply was connected to the socket outlet, see Figure 3. The plug part (Figure 4) with the socket outlet was not subject of the test. Test results do not relate to the whole power supply but only to the enclosure (without the plug part).

Socket
outlet

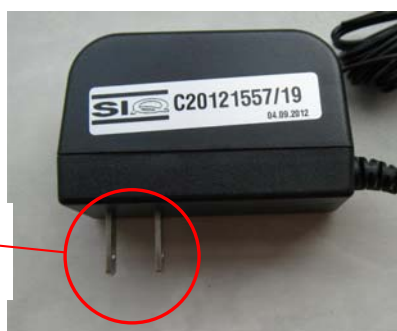
Figure 4: sample unit

Plug part

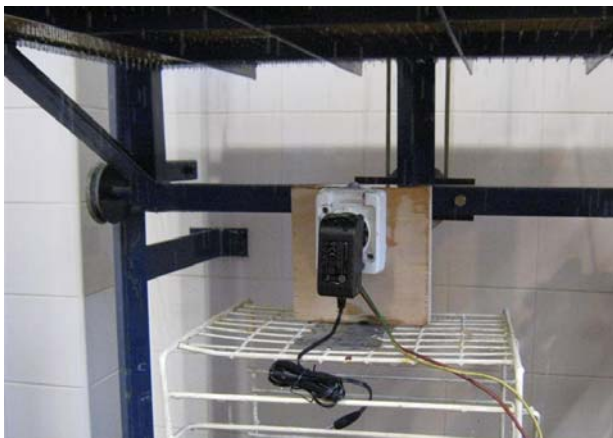
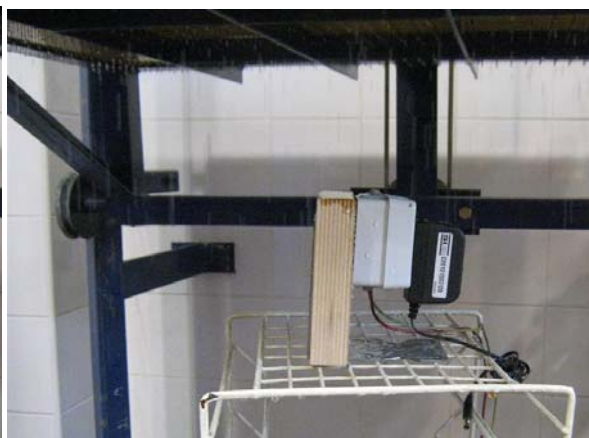
Figure 5

- Test device, drip box-as specified in standard,
- Water flow rate: 1 mm/min,
- The test sample was placed on the turntable under the drip box in most unfavorable normal position (Figures 5 and 6),
- Duration of the exposure: 10 minutes,

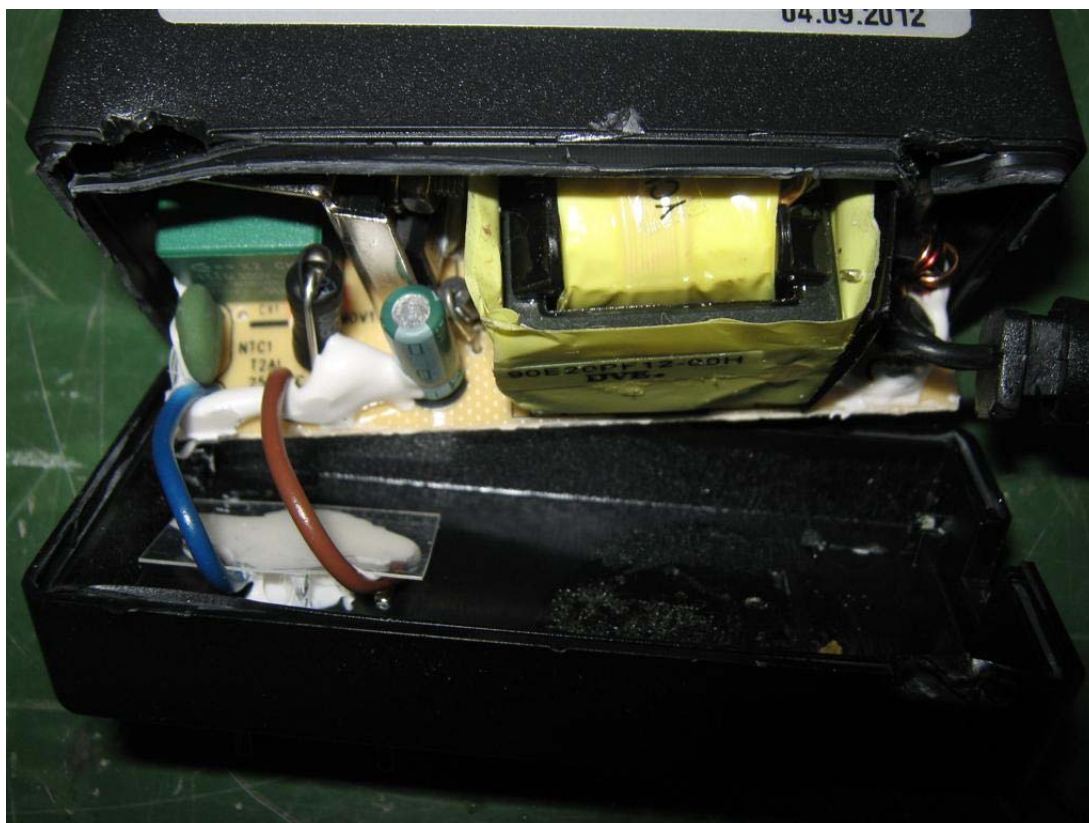
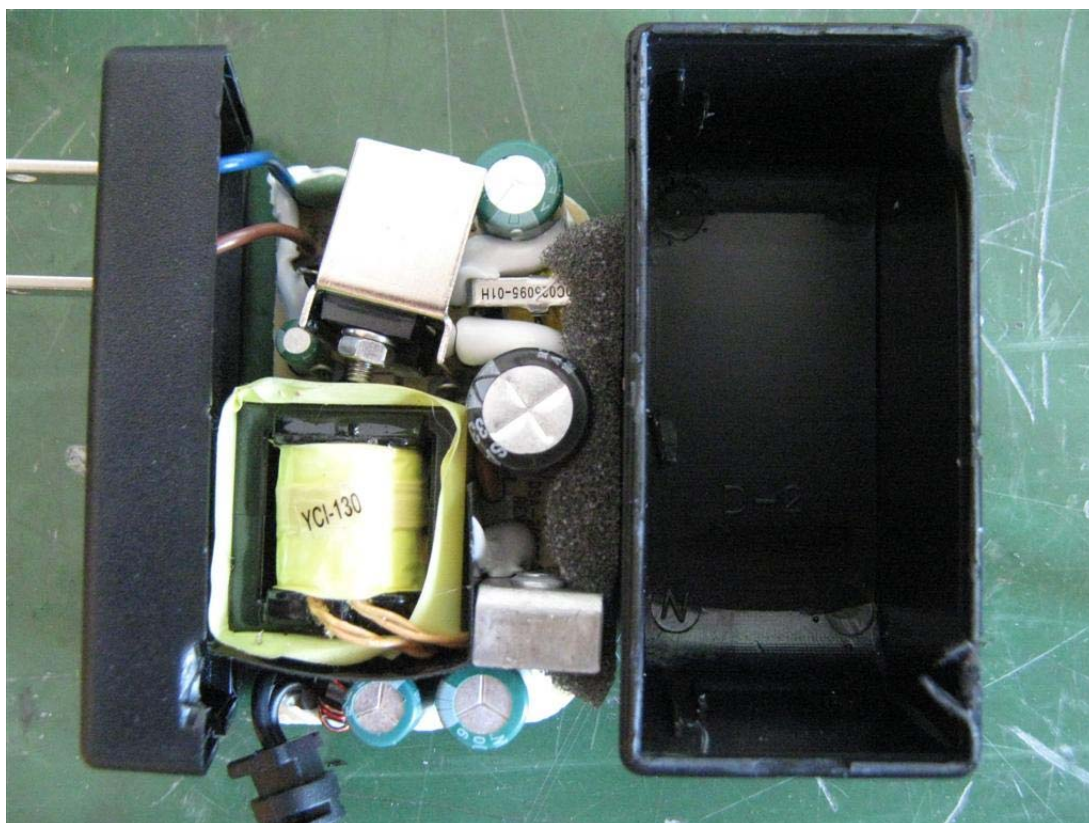
Figure 7

Conclusion: After the water test there was no water inside the enclosure (Figures 7 and 8).

- The rigid test wire was not penetrated into the enclosure
- After the IPX1 test there was NO water inside the enclosure.
