# Poročilo o preskusu / Test Report

T211-0456/12

<b>Proizvod / Product</b> Power supply Model: GT-81081-WWVV-X.X-T3 series, GT-81091-WWVV-X.X-T3 series GT-81081-WWVV-X.X-T3A series, GT-81091-WWVV-X.X-T3A series Enclosure: TR9CE5000Q00-F(R)	<b>Listov / Pages</b> 3
<b>Naročnik / Applicant</b> GlobTek, Inc 186 Veterans Dr, Northvale, NJ 07647 / USA	<b>Vrsta preskusa / Test procedure</b> IP40, IP41
<b>Proizvajalec / Manufacturer</b> GlobTek, Inc 186 Veterans Dr, Northvale, NJ 07647 / USA	<b>Št. Merjencev / No. of Items tested</b> 1
<b>Blagovna znamka / Trade Mark</b> GlobTek	<b>Mapa predmeta št. / Subject File No.</b> C20121557
<b>Standardi – predpisi / Standards – regulations</b> IEC 60529:2001	<b>Kraj preskusa / Place of test</b> SIQ - Slovenian Institute of Quality and Metrology, Tržaška 2, 1000 Ljubljana, Slovenia
	<b>Opomba / Remark</b> /

## Zaključek / Conclusion

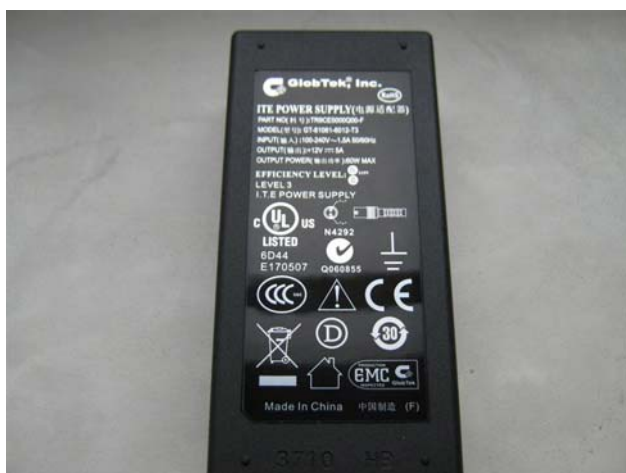
Figure 1

Power supply, model GT-81081-WWVV-X.X-T3 series, GT-81091-WWVV-X.X-T3 series, GT-81081-WWVV-X.X-T3A series and GT-81091-WWVV-X.X-T3A series, enclosure TR9CE5000Q00-F(R) was subjected to testing for IP41 degree of protection (Figures 1 and 2).
