GlobeTek, Inc.

**Pre-compliance Test Report
for
GT3T41-12-150R-3**

Device Under Test	
Date	January 31, 2017
Tested by:	EV
Model No	GTM3T41-12-150R-3
Part No	WR23E150SRP-N-MED
Description	12V/150mA , 1.8W
Serial Number	DC 5015
Customer	SECA
Type of Test	Surge, EFT, ESD
Pass/Fail	PASS
Comments	1 unit tested for Surge, EFT & ESD for compliance to EN60601-1-2 4 th edition. Passed.

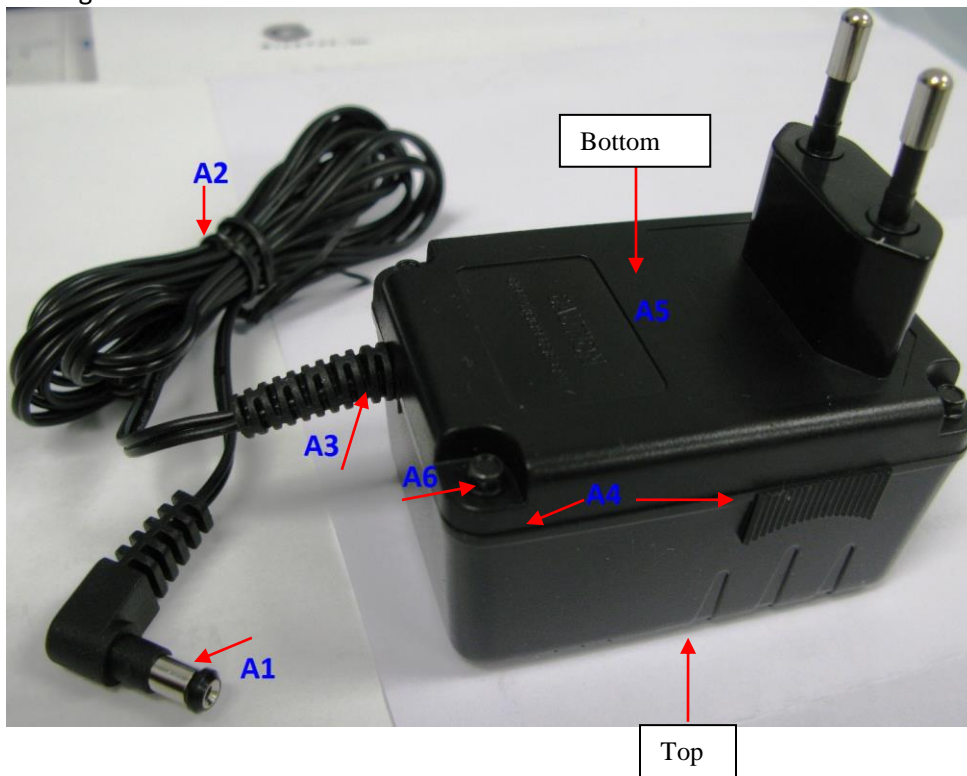
Test point diagram:

Test Points	Test Levels (KV)		Observation
	+8KV	-8KV	
A1 Exposed Ground Wire	Pass	Pass	2
A2 Cord Output	Pass	Pass	2
A3 Strain relief	Pass	Pass	2
A4 Enclosure SEAM	Pass	Pass	1
A5 Enclosure surfaces (Top, Bottom & 4 Sides)	Pass	Pass	1
A6 Housing Screws	Pass	Pass	1

Test Points	Test Levels (KV)		Observation
	+15KV	-15KV	
A1 Exposed Ground Wire	Pass	Pass	2
A2 Cord Output	Pass	Pass	1
A3 Strain relief	Pass	Pass	1
A4 Enclosure SEAM	Pass	Pass	2
A5 Enclosure surfaces (Top, Bottom & 4 Sides)	Pass	Pass	1
A6 Housing Screws	Pass	Pass	1
